Case Study

DULEY RESIDENCE: SEAWALL REPAIR AND RESTORATION

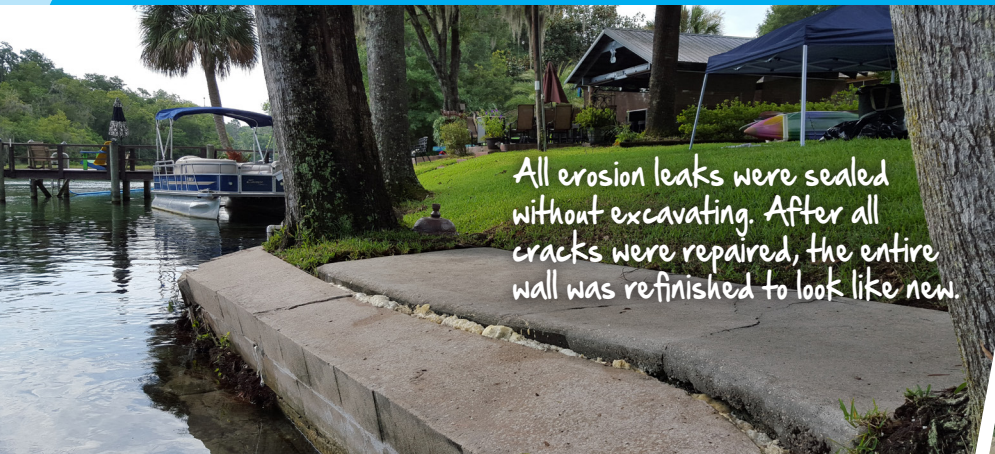
All erosion leaks were sealed without excavating. After all cracks were repaired, the entire wall was refinished to look like new.

1. Seal leaks in cracks, joints and undertow to prevent future erosion from land side.
2. Structural repair of cracks with epoxy.
3. Form and pour new cap to level seawall. Resurface cap to level seawall. Resurface cap and wall face with special cementitious coating design.

Stable Soils achieved this injection with no gel moving past the face of the wall. We sealed all leaks, stabilized soils, epoxied cracked concrete, sealed all holes, cracks, spalls, reinforced and poured new cap in a timely manner with no excavations or interruptions to the use of the area.

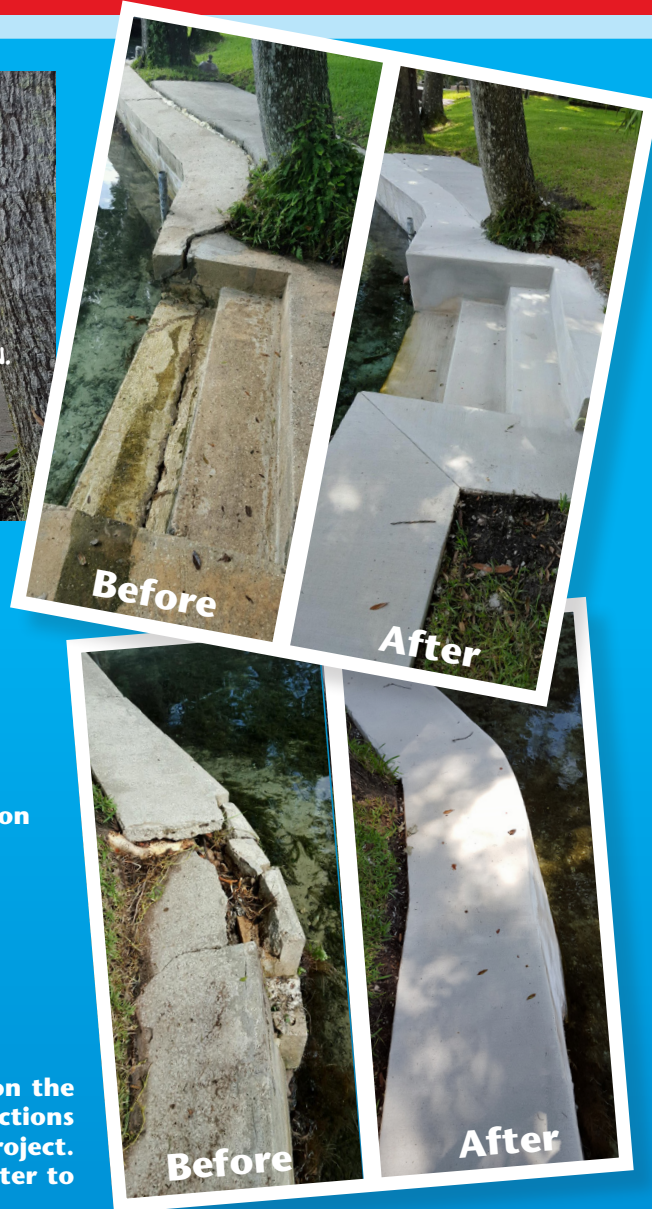
The residence owner contacted Stable Soils of Florida to inspect and provide a solution to repair their existing CMU Concrete block poured cells solid seawall on Blue Run.
