Stable Soils™

The Poly Grout Professionals

Long Lasting Soil Solutions for a Stable Future

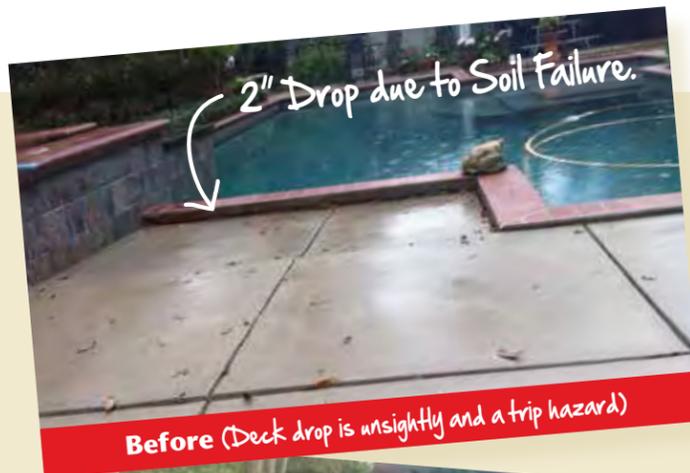
Before (Deck drop is unsightly and a trip hazard)

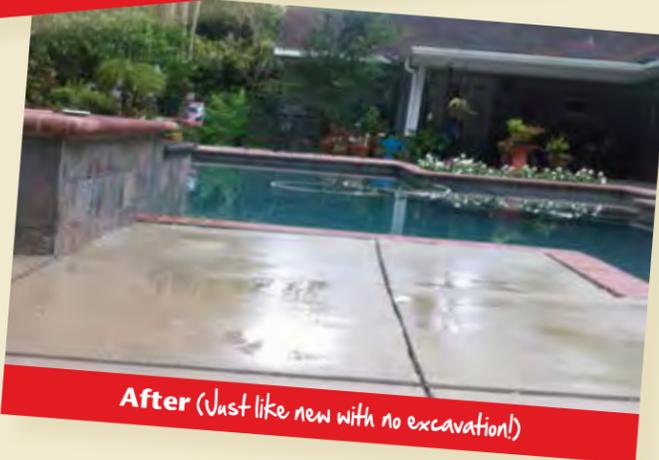
After (Just like new with no excavation!)

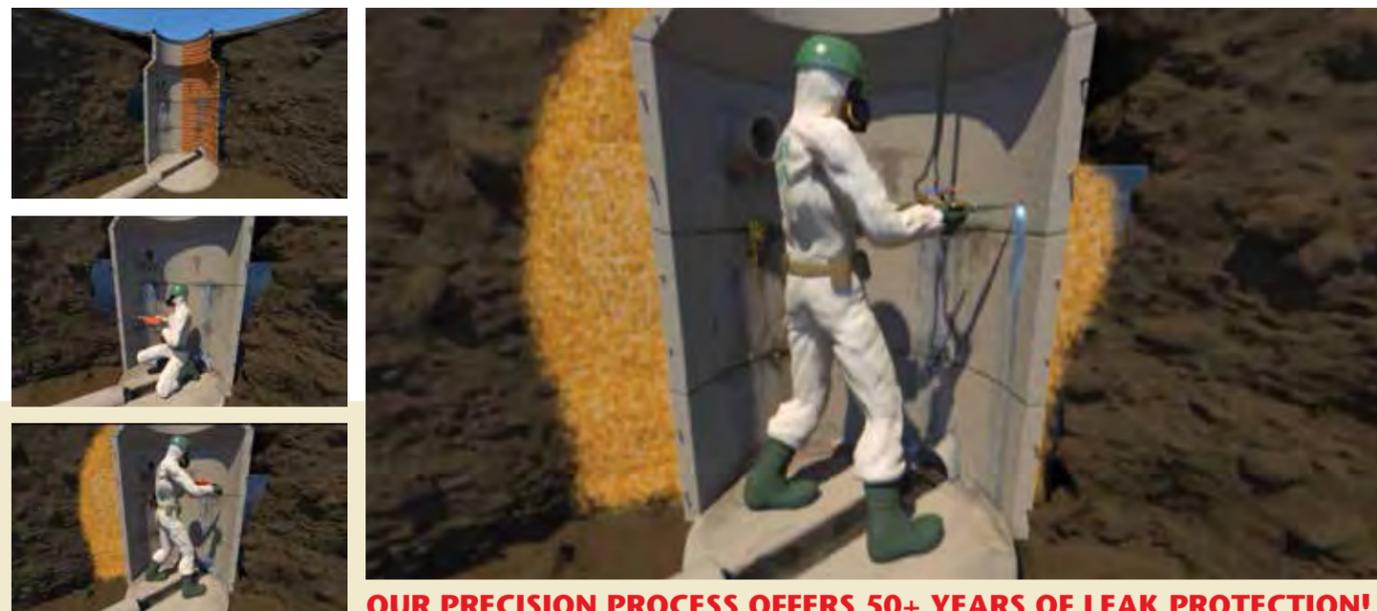
Our process of sealing begins with injecting a 2-part polyurethane under high pressure to the outside of the structure to penetrate the voids and leaks from the outside, in. This allows for little or no chance of failure as this product will last indefinitely unless exposed to direct sunlight for long periods. And best of all, the back-pressure of the leak acts to pull the chemical grout into the structure. This product flows as a liquid to find all leaks and cracks and permanently seals them as it expands 20+ times its volume as a liquid. This not only stops the leaking and seals the structure, it compacts the weak soils and fills voids found outside the structure to help support surface soils and road beds, and it will not over-burden the surrounding soils.

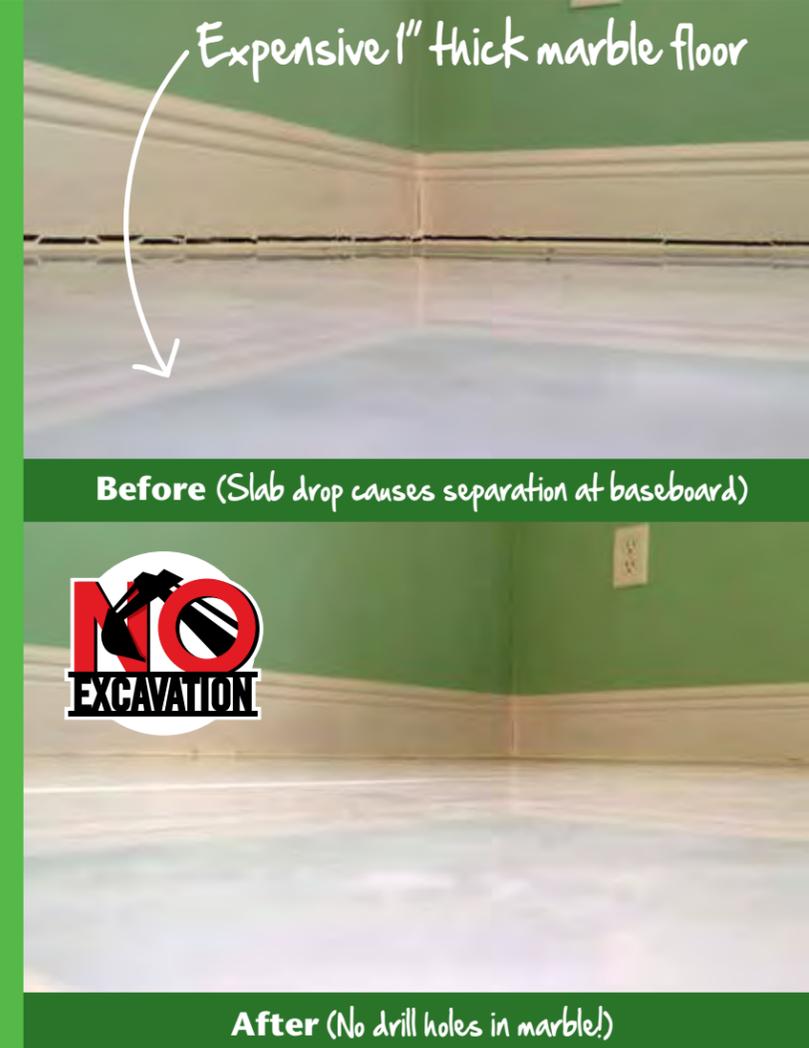
Before (Slab drop causes separation at baseboard)

After (No drill holes in marble!)

After team collaboration with multiple members of Stable Soils, we drilled through the side of the home to save their costly marble floor and injected our 2-part expanding polyurethane material to lift the slab back to level. This was the first time we completed a slab lift without drilling directly through the deviated slab. The work was completed with ZERO damage done to the flooring and with an extremely satisfied customer! We have no limits for repair work.

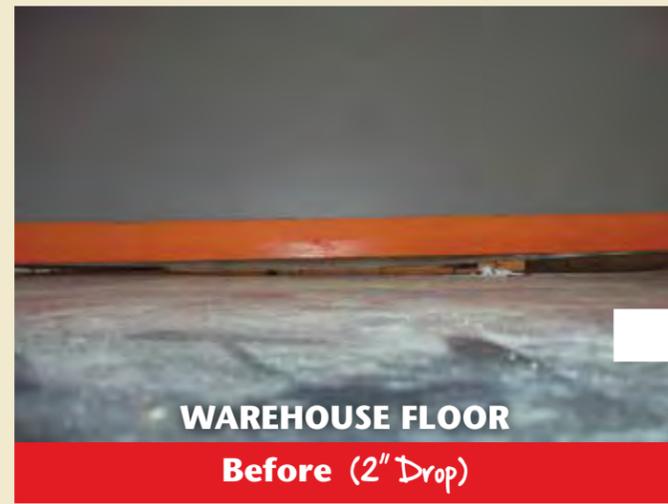
WAREHOUSE FLOOR
Before (2" Drop)

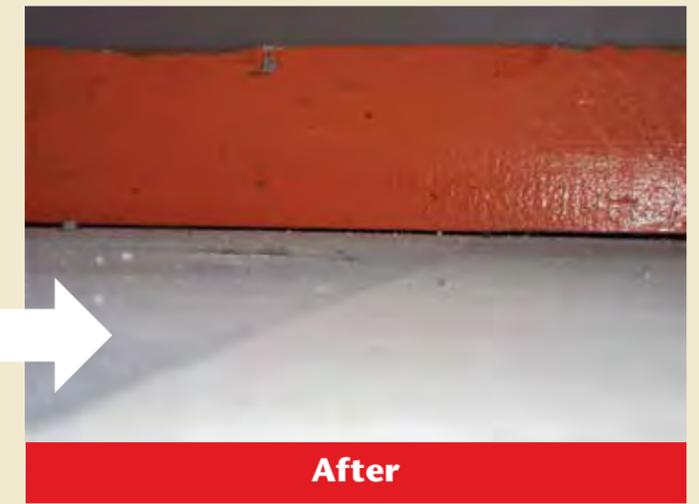
After

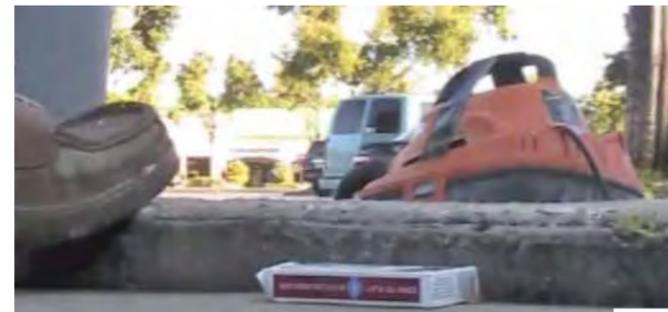
LOADING DOCK FLOOR
Before (3" Drop)

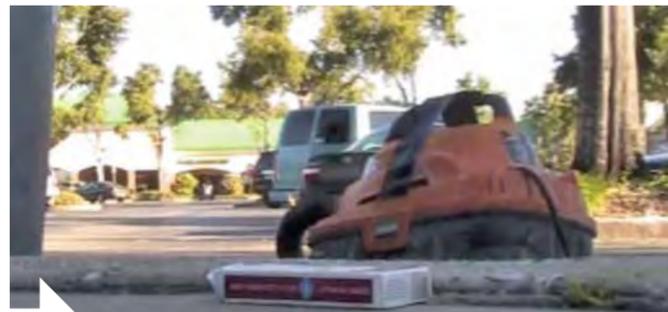
After (Note the Deck of Cards)

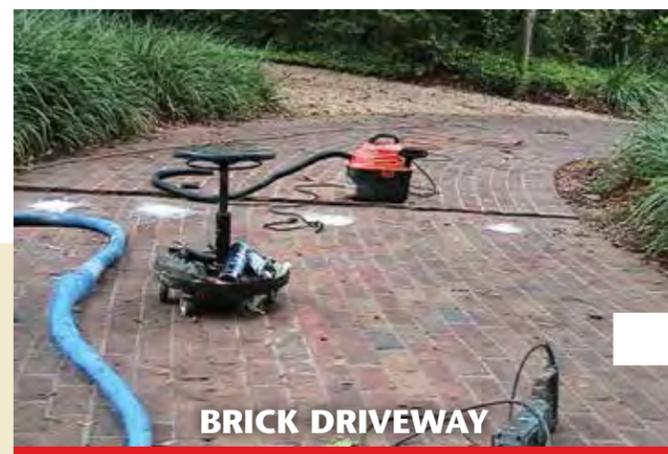
BRICK DRIVEWAY
Before (1" Speed bump)

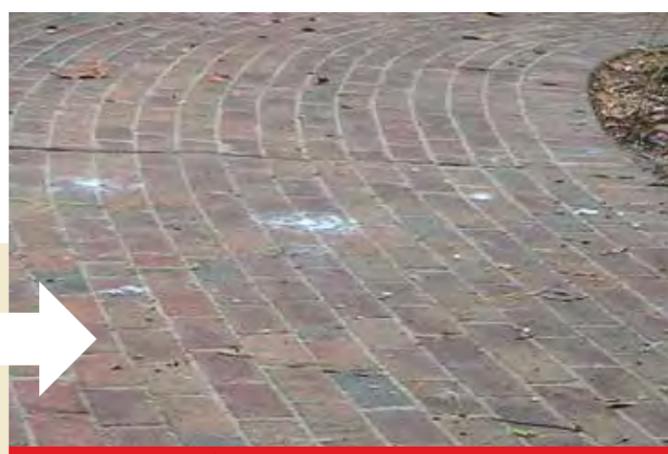
After (Like new with no costly excavation)

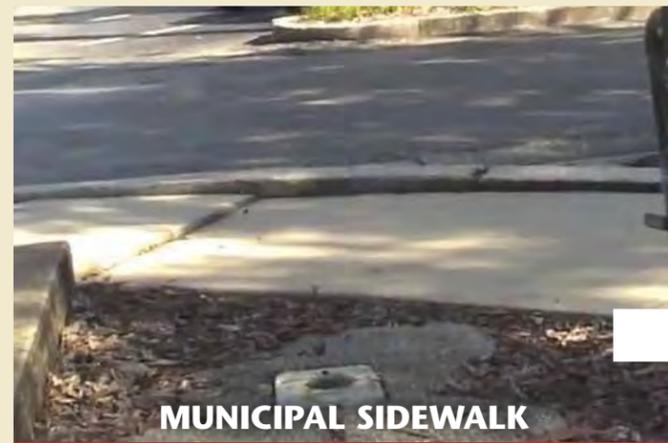
MUNICIPAL SIDEWALK
Before (3" Drop)

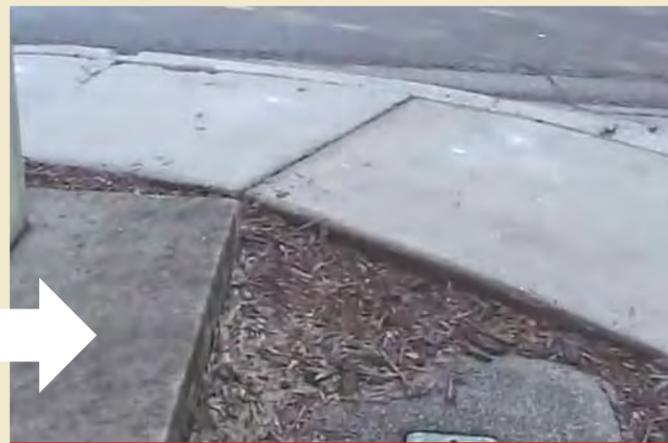
After (Eliminates the risk of lawsuit)

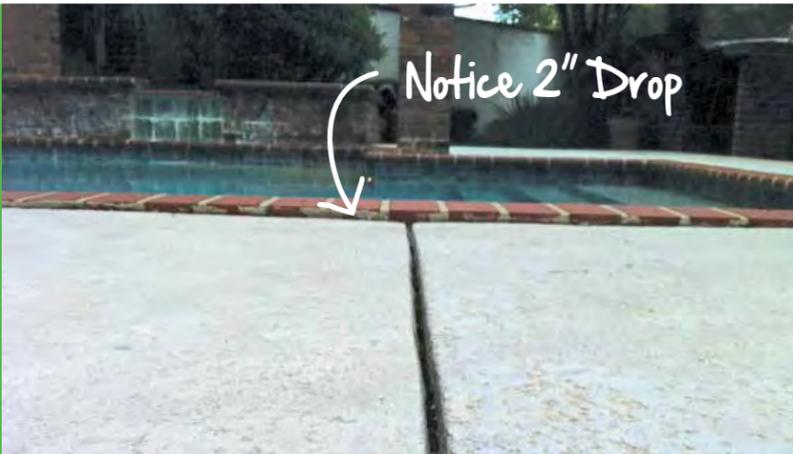
Before (Deck drop is unsightly and dangerous)

In June 2012, Stable Soils received a phone call from a home owner whose pool deck had settled and had sunk up to 2" in a particular area. They had received quotes from rip out and replacement contractors which demanded high costs and a week of jackhammers, removal of material, placement of new material, and a lot of undesired foot traffic. Stable Soils completed this job in less than 4 hours, for 1/2 the cost, and with ZERO EXCAVATION required! Quick, Clean, Quiet! We do it right! We do it for good!

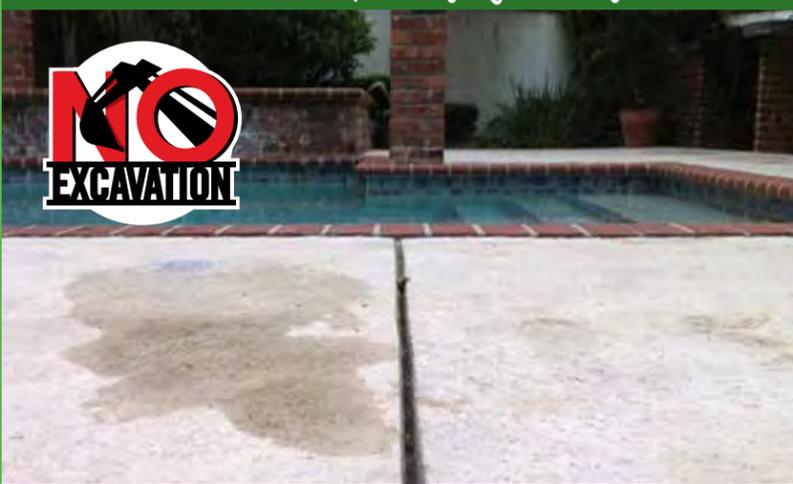
After (Just like new with no excavation!)

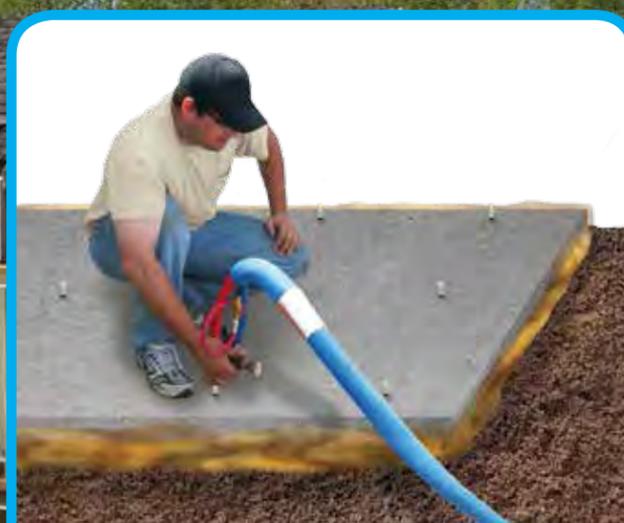
HOW IT WORKS

Professionally injected polyurethane seals the concrete from the underside. Our unique product travels and coats the bottom and sides of the slab, creating an impenetrable vapor barrier.
